Optima / Sorento / Sportage Sunroof Glass Status

Kia Motors America 05/31/2013

Panorama Sunroof Glass Summary

XM Panorama Glass Investigation

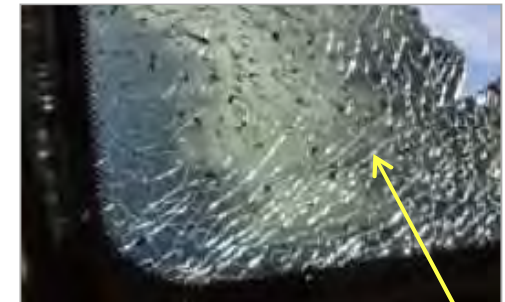
❖ During the inspection, TFT observed fragmentation had occurred in the center of glass. Fragmentation occurred from the center of the glass and as a result, consequential damage occurred to the paint.

❖ The Investigation results are **Inconclusive** as to the "Root Cause" of this condition. Panorama sunroof front glass was recovered for further analysis.

Fragmented in Center of Glass

Circular fracture configuration

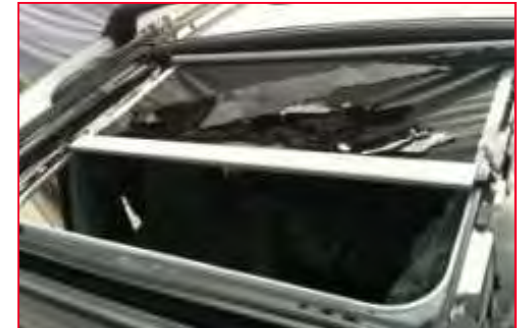
- ❖ During the inspection, TFT observed fragmentation occurred of the sliding glass. consequential damage occurred to the roller shade
- ❖ The Investigation results are Inconclusive as to the "Root Cause" of this condition.
- ❖ There is no damage to surrounding painted area from rock/debris (Various road hazards)
- ❖ All frame support bars have inspected, no loose glass to bracket

Sliding glass completely fragmented

- ❖ Remaining glass pieces and supporting frame were taped up to prevent further damage during shipping
- ❖ The glass and all four reinforcement bars were sent to Rochester, MI for further analysis in the lab
- ❖ The glass temper and cracking angles will be investigated and reporting will be sent to KMMG
- ❖ FPQR

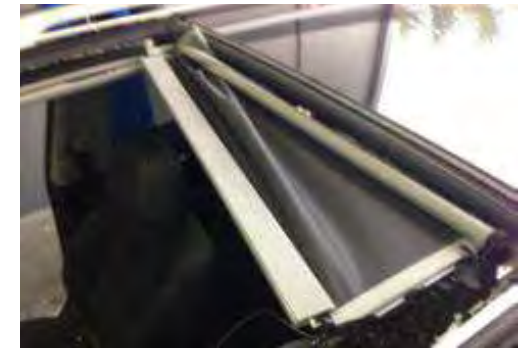
- ❖ Large dent which should have required some force found on left side of roof very close to leading edge of glass was most likely the impact which caused glass to shatter

Glass Fragmented, Shade Forced Back

- ❖ Vehicle currently part of a CA case and Pano Roof assy is not be removed but preserved in place for evidence
- ❖ Pano Roof glass fragmentation does not appear to be due to any material defect but rather it was due to impact with road debris and thus it is not going to be valuable for further investigation by the supplier or KMMG

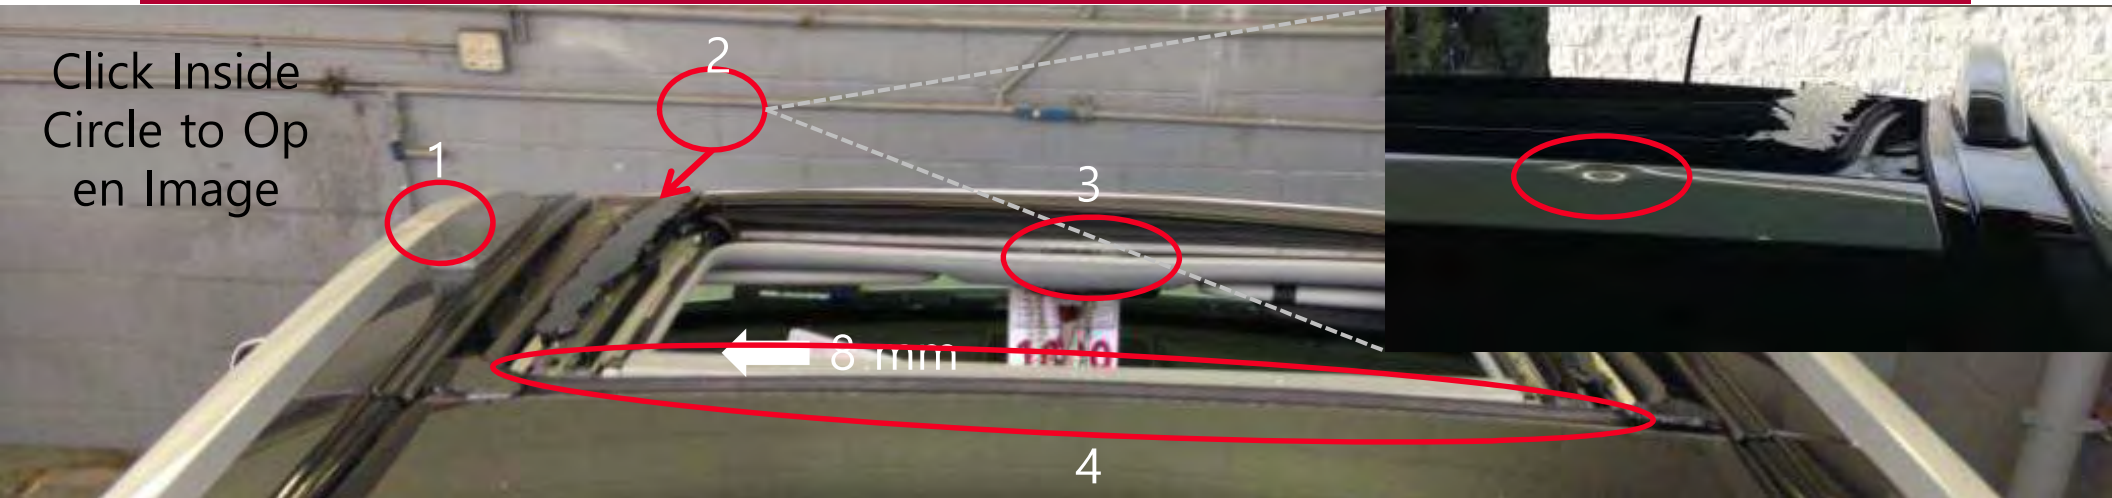
1. Scratches on inside toward the leading edge of the left side roof rail, aft of the large dent at left side of roof panel shown as #2. Note: Customer claims that they never used the roof rails to tie down any cargo since purchasing the vehicle, negating any plausible explanation for scratches found here being due to tie down hooks or cargo

2. Large dent at left side of roof panel. This dent is in right at the leading edge of the glass and an object which impacted with the force necessary to cause such a dent this close to the glass would also shatter the panoramic roof glass. We can demonstrate this on video showing a measured weight coming down at known velocity to exhibit similar dent and shatter the glass should this evidence be necessary for trial

3. Evidence of a strike near the center of the plastic trim piece (air dam) just forward of the panoramic roof opening. This impact caused the polymer to turn white due to the bending force applied to the material, caused a small cut about 3 mm deep, and impacted the edge of the headliner leaving a visible angle of deflection

1. There is a scrape mark with striations visible moving from front to rear on the top leading edge of the sunshade. The sunshade was also pushed rearward at an uneven angle. The customer claims that the sunshade was closed when the event occurred. The debris which caused the damage transferred some dirt or other material to this sunshade handle/cross bar.

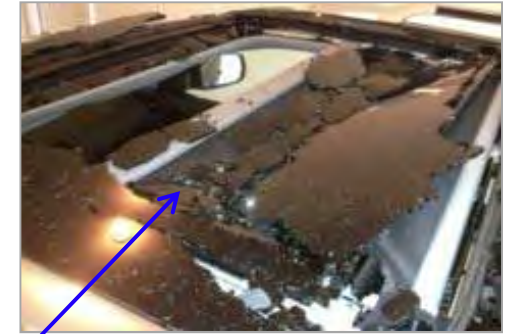
- ❖ Investigation was conducted in the customers garage (1/29/2013) AR017
- ❖ During the inspection, the TFT observed fragmentation had occurred in the front panorama sliding glass. It was also observed that the fragmentation occurred from the center of the glass.
- ❖ It is also **conclusive** the condition occurred while vehicle was stationary in the garage based on surrounding fragmented glass
- ❖ The Investigation results are **Inconclusive** as to the "**Root Cause**" of this condition. Panorama sunroof front glass was recovered for further analysis. Analysis to be completed by Supplier Webasto MI

Fragmentation in Center of Glass

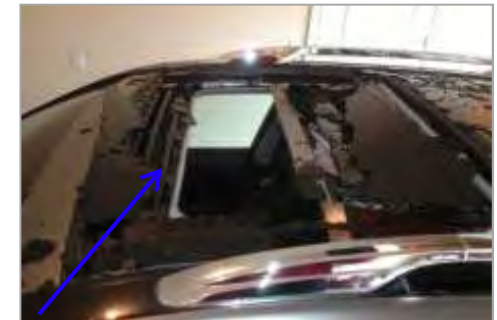
- ❖ VIN = 5XYKWDA25DG^{REDACTED} / MILES = 500
- ❖ 13MY Sorento SX AWD
- ❖ Production Date : 10/21/2012
- ❖ Incident occurred while vehicle was stationary in garage
- ❖ Customer stating identified condition when entering garage in the morning.
- ❖ Sunroof closed / Sunshade was semi open during occurrence
- ❖ No additional information was provided by customer

Fragmentation occurred in Garage

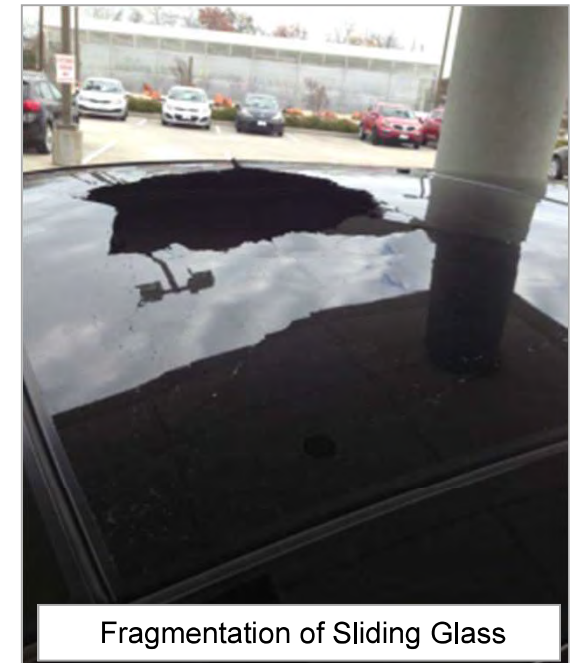
- ❖ The customer was traveling on a surface street with the roof closed at about 30 MPH when she heard a crack/crunch and when she stopped she found the sunroof glass had come apart.
- ❖ the sunshade was fortunately closed as all the broken glass was on top of the shade

- ❖ **No obvious point of impact was found.**

Fragmentation of Sliding Glass

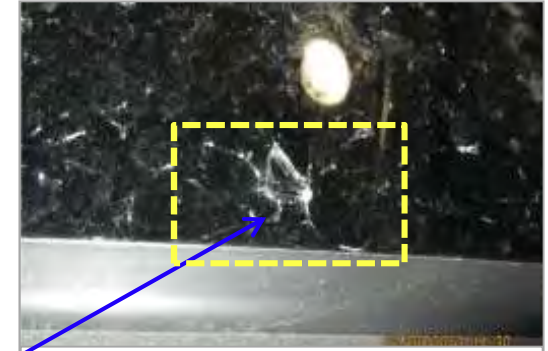
- ❖ Found that the glass had fragmented, and there was a chip, in the glass near the edge at the RF of the sunroof

Impact Mark Identified

- ❖ **Corrective action** – Replace sunroof glass assembly, clean area of glass.

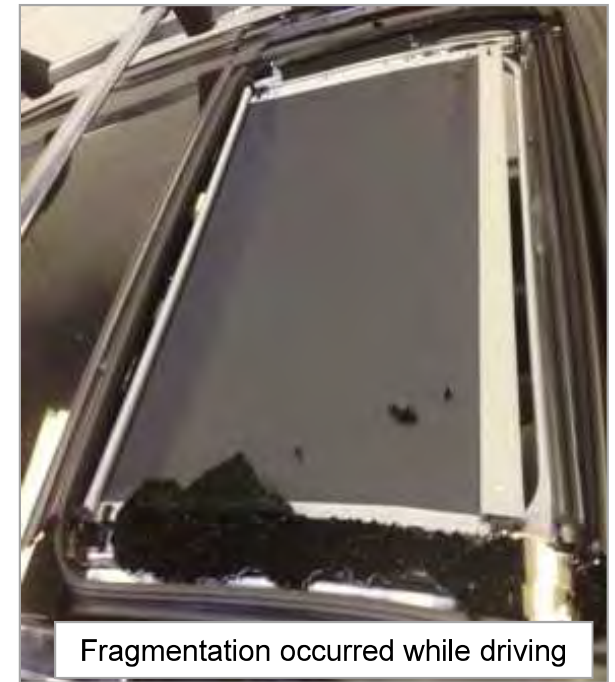
Fragmentation occurred while driving

- ❖ **Corrective action** – Replace sunroof glass assembly, clean area of glass.

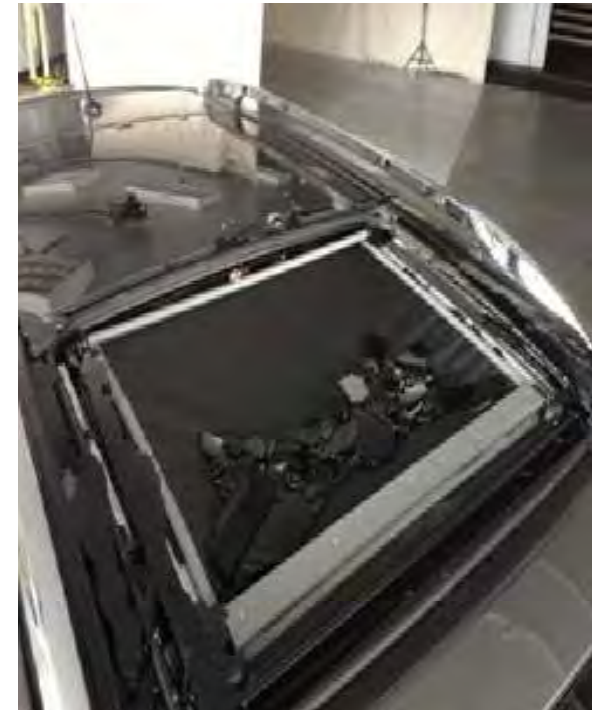
- ❖ DPSM and RPSM Physically inspected the vehicle for any signs of object strike, none were found
- ❖ **Corrective action** – The panoramic roof glass front and rear were replaced as per PQ and DPSM

Fragmentation occurred while driving

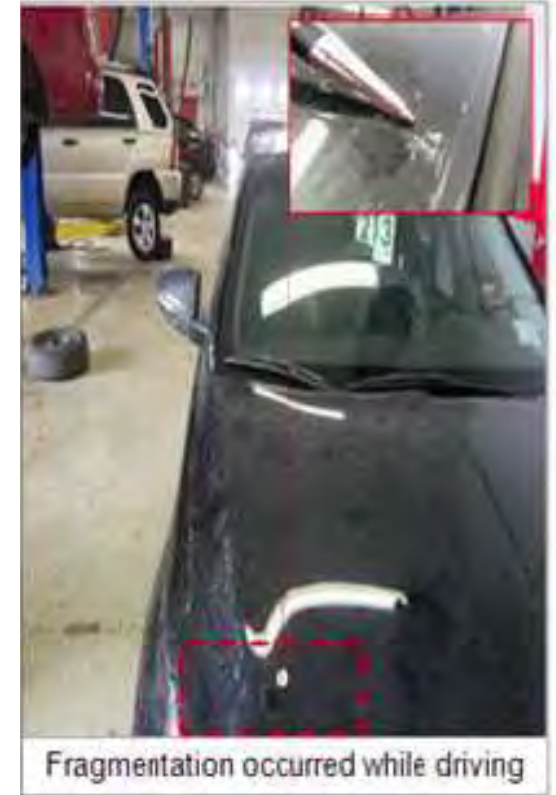
- ❖ FTR inspected vehicle. Roof glass was broken. Inspected glass area for impact. Impact mark was evident on the RF leading edge of the glass
- ❖ Inspected the hood and front grill area for any stone chips and initial impact points. There were several stone chips on the hood area. One stone impact on the RF hood area was in direct line of the impact on the leading edge of the sunroof glass. No evidence of defect was found on the glass or sunroof during the inspection. Outside influence by a rock or road debris seems to be the cause of glass failure.
- ❖ **Cause** - Outside influence by a rock or road debris seems to be the cause of glass failure
- ❖ **Corrective action** – Replacement of the sunroof glass assembly

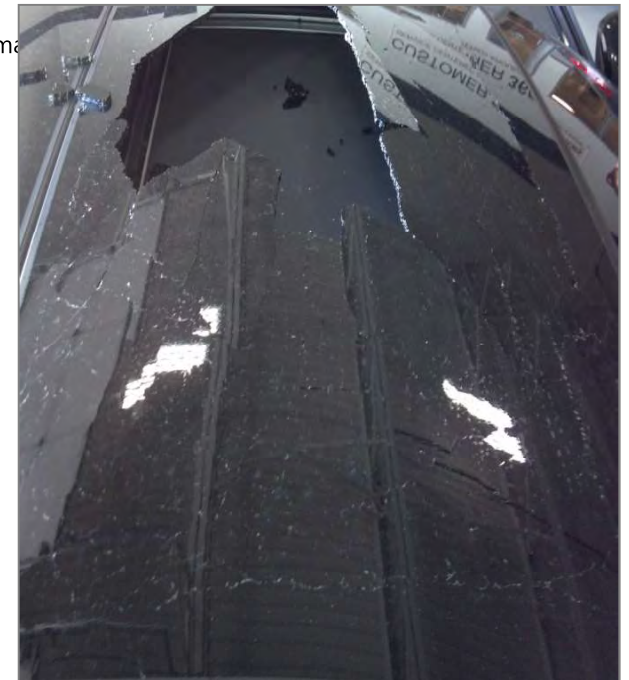
- ❖ Looks like sunroof blew out from the inside out
- ❖ **Cause** -Unknown
- ❖ **Corrective action** – Replace the Glass Sunroof.

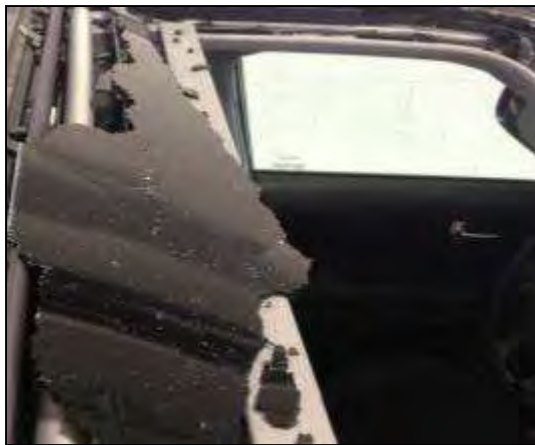
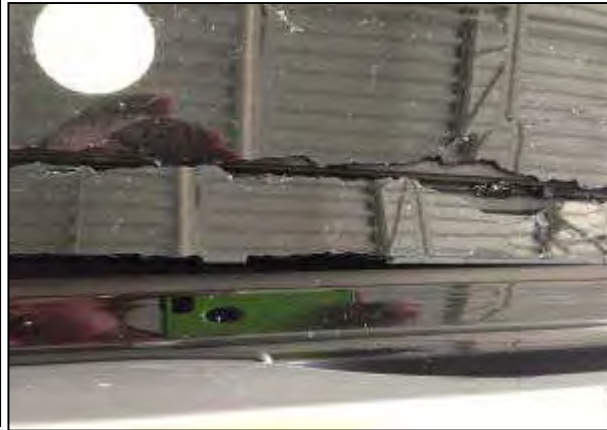
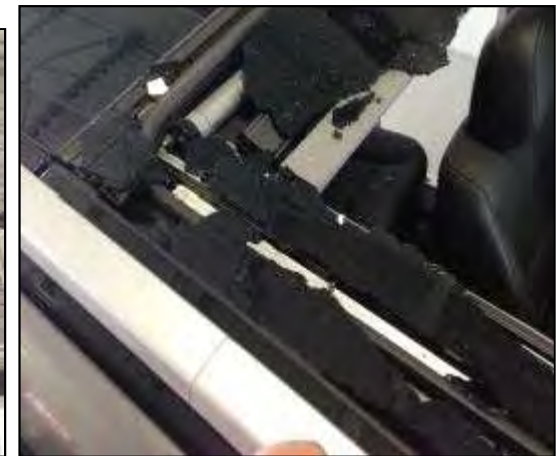
- After glass analysis by Guardian, damage to glass appears to have started on right side of the glass. No other areas on the glass still present on the vehicle showed a web-like break pattern as found on the right side. This web-like break pattern indicates where the crack began due to some sort of external impact to the glass.
- No foreign debris found within the sunroof track or vehicle.

Pictures directly above show how the glass did stay adhered to brackets showing no signs of e-coat separation and fragmented as tempered glass should.

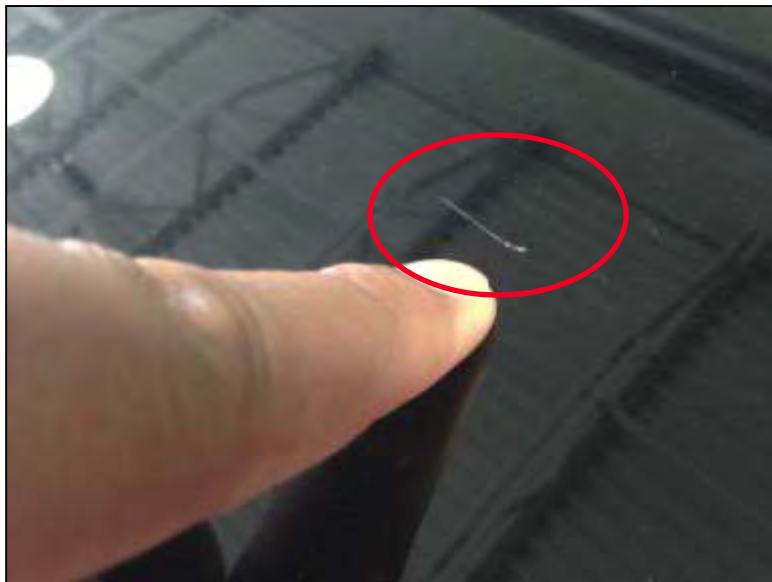
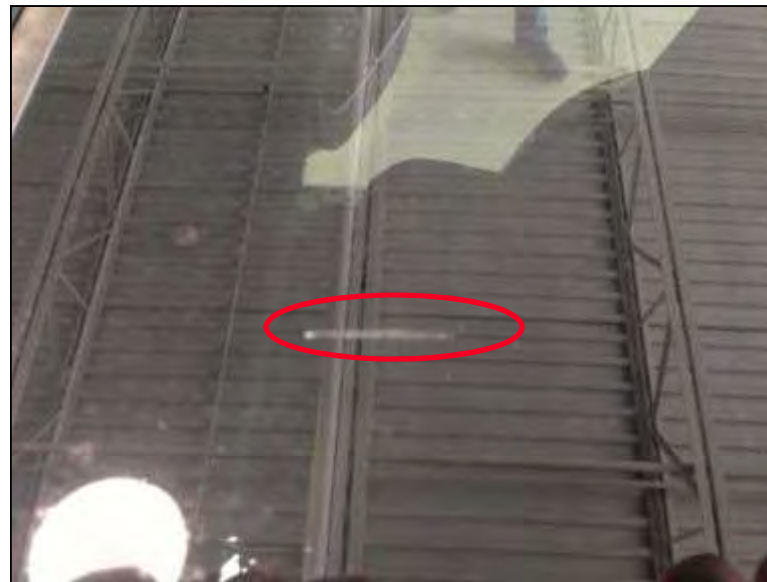
Witness Markings on Rear Glass Panel

Some scratches were noticed on the rear glass. There are two potential causes:

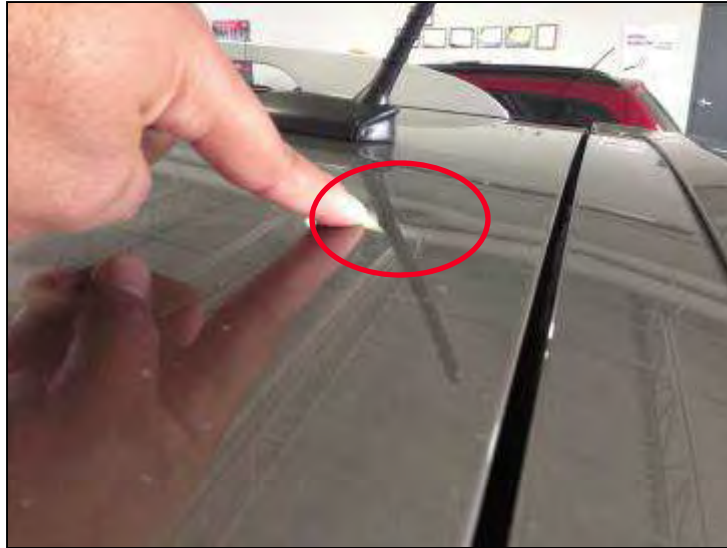
Dimple marking in the sheet metal on the left side of the antenna which may indicate the customer has used some sort of apparatus to mount something (Possibly kayak) to the roof which could potentially damage the panorama glass depending on what was mounted. However no roof rails were present. These markings were noticed during investigation of unit.

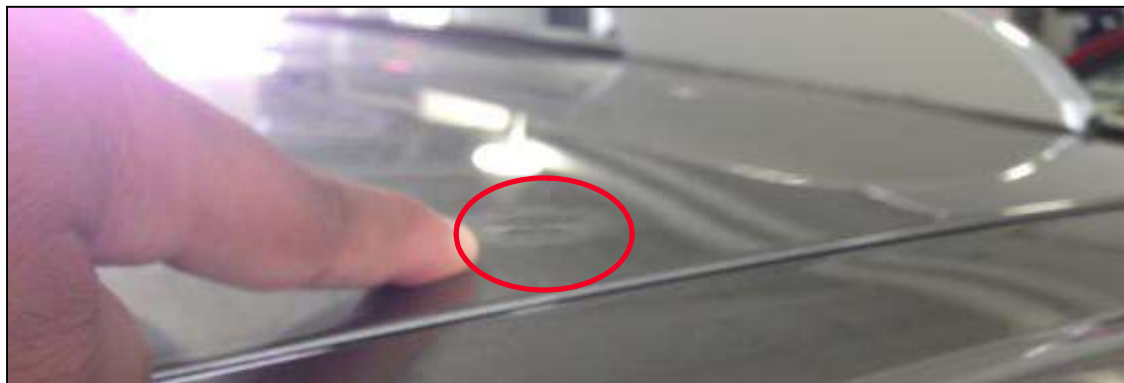
Dimple marking in the sheet metal on the right side of the antenna. Markings were evenly spaced away from the antenna on left and right.

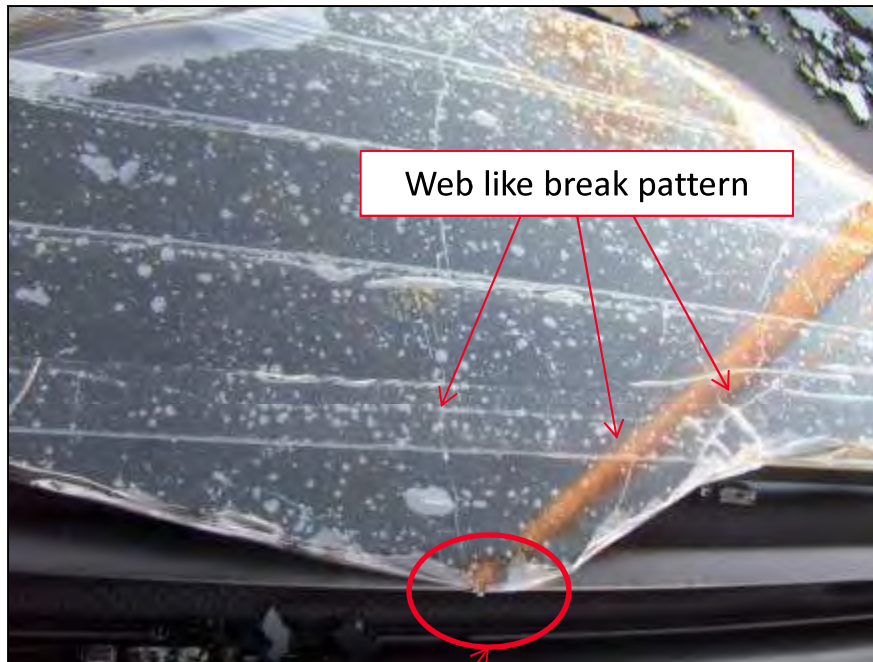
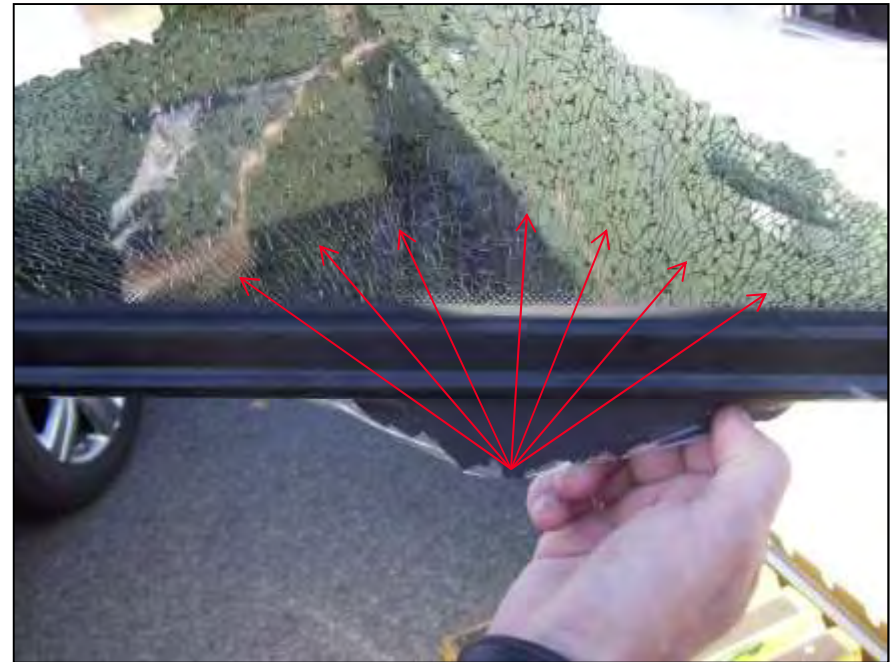
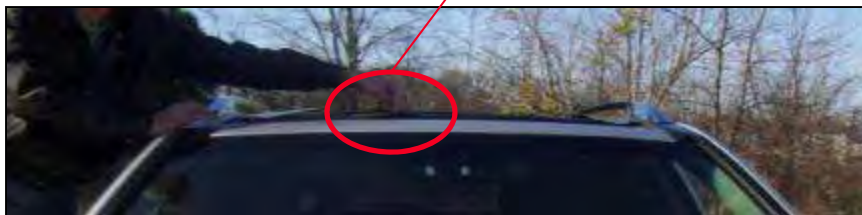
- After glass analysis, damage to glass appears to have started at the front of the glass toward the right side of the vehicle. No other areas on the glass present on the vehicle showed a web-like break pattern as found in this area. This web-like break pattern indicates where the crack began due to some sort of external impact to the glass which could have occurred prior to glass fracturing.
- No foreign debris found within the sunroof track or vehicle.

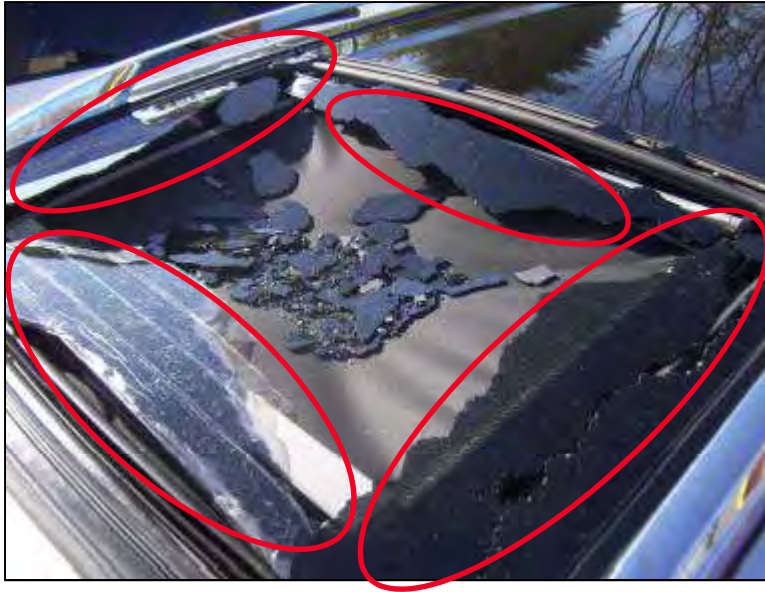
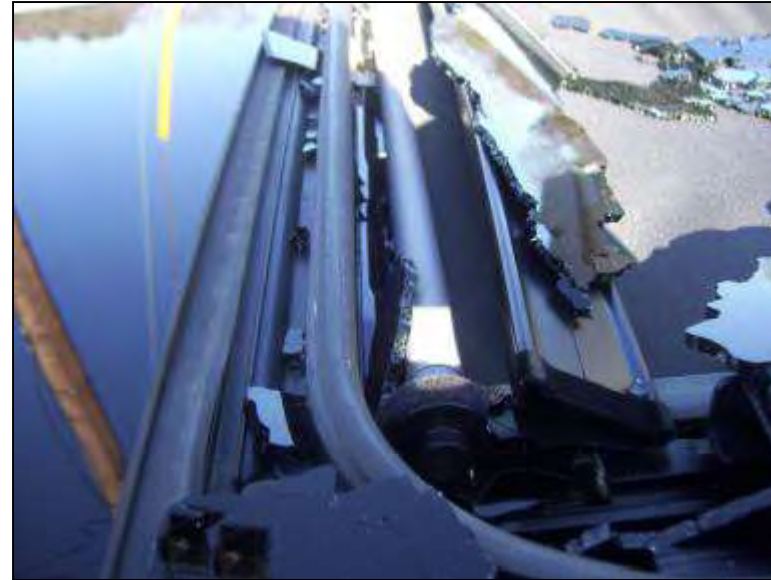
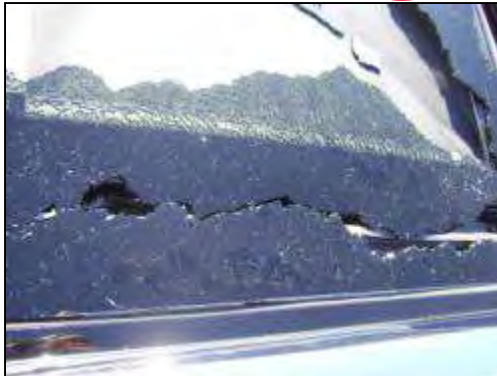
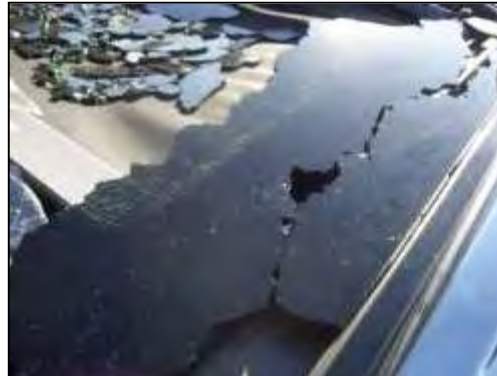
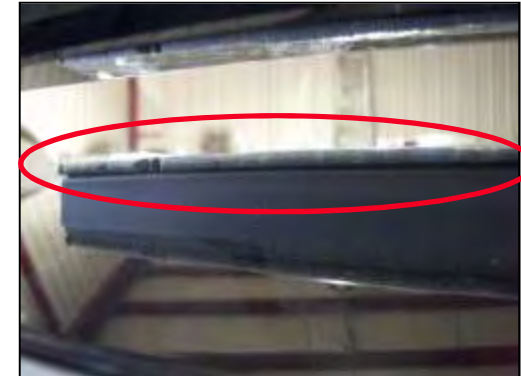
- Pictures directly above show how the glass did stay adhered to brackets showing no signs of e-coat separation and fragmented as tempered glass should.
- All brackets were shipped back to Webasto for additional testing to verify no concerns.
- Sunroof history can also be checked by Webasto using the barcode label on one of the brackets. This information will yield information about if the panel was repaired for any concerns at Webasto.

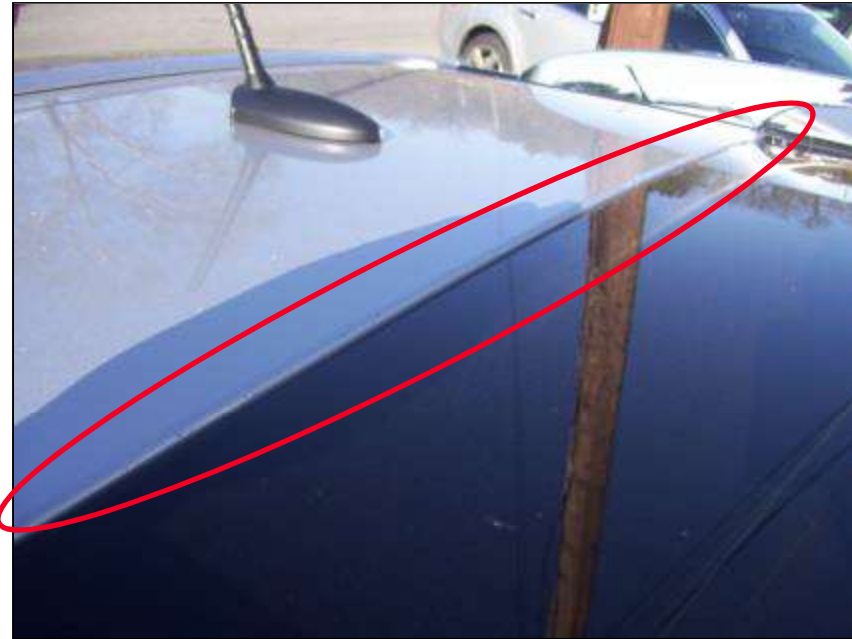
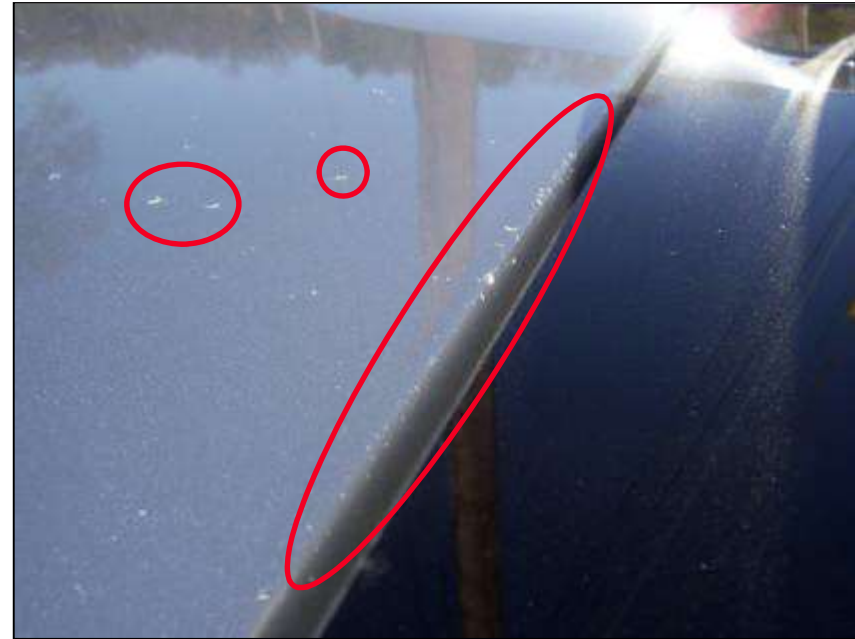
- During evaluation it was noticed that there was some paint damage at the rear of the vehicle on the painted surface. This could have been caused by glass fragments that blew back after the front panel fractured. Fragments could have been blown back as the vehicle was towed in to dealer for repair also.
- This has not been noticed on any other prior investigations for similar concerns.

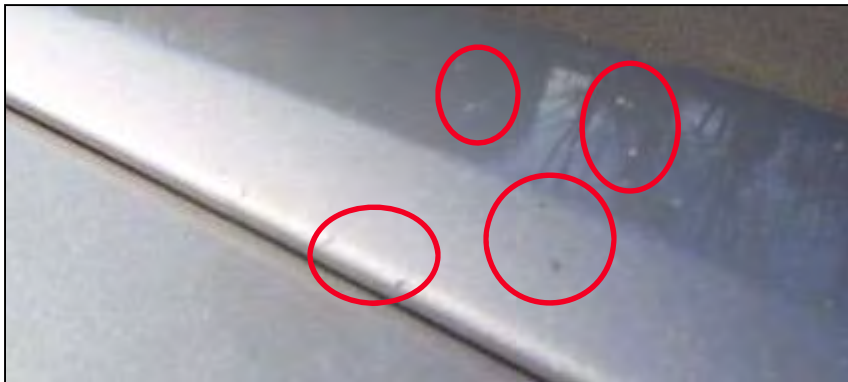
- Similar damage was also noticed on the spoiler as seen in the photo to the left.

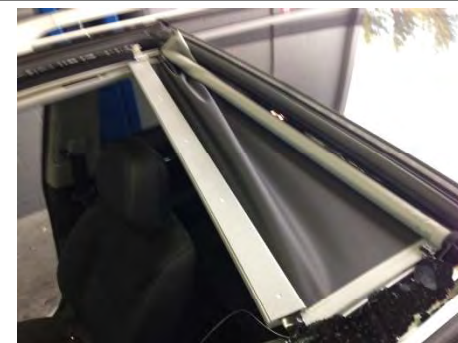
Glass Shattered, Shade Forced Back

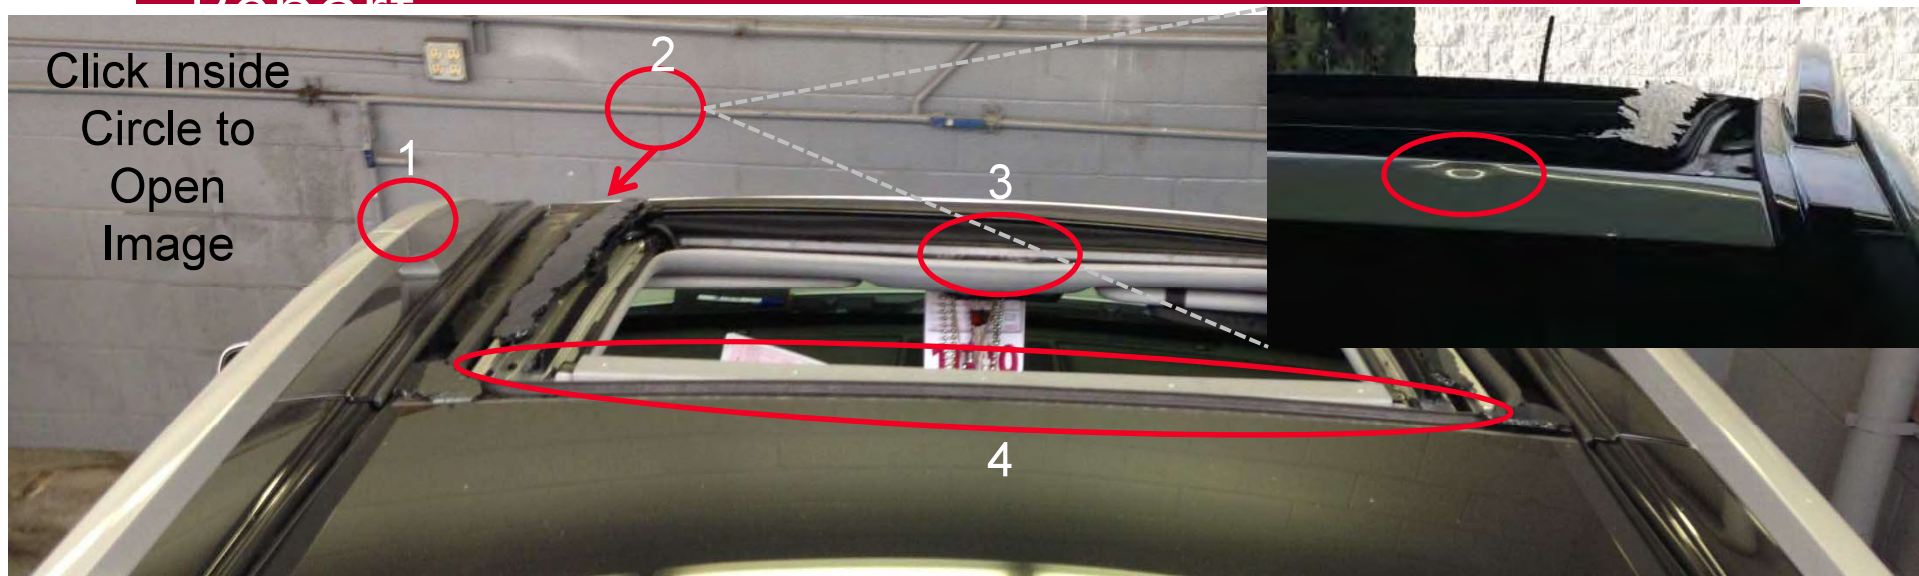
1. Scratches on inside toward the leading edge of the left side roof rail, aft of the large dent at left side of roof panel shown as #2. Note: Customer claims that they never used the roof rails to tie down any cargo since purchasing the vehicle, negating any plausible explanation for scratches found here being due to tie down hooks or cargo

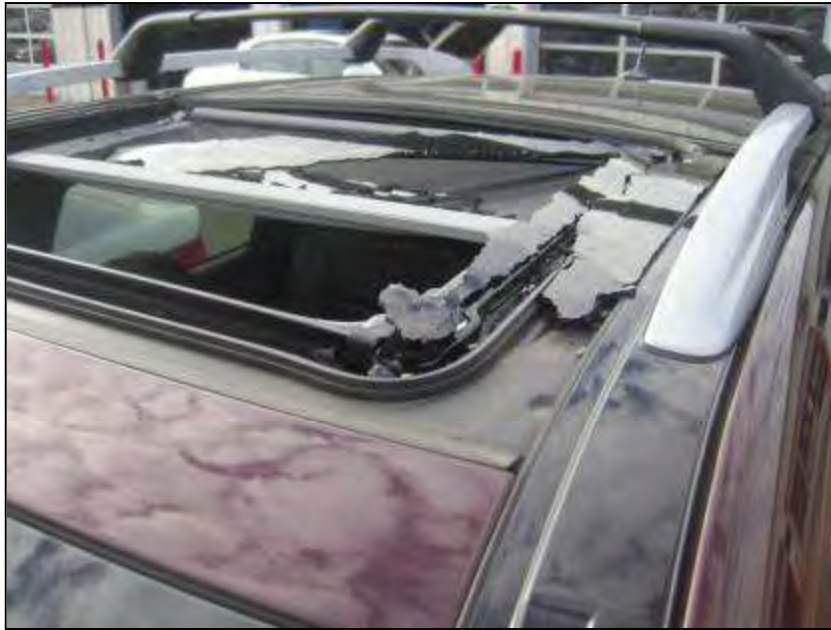
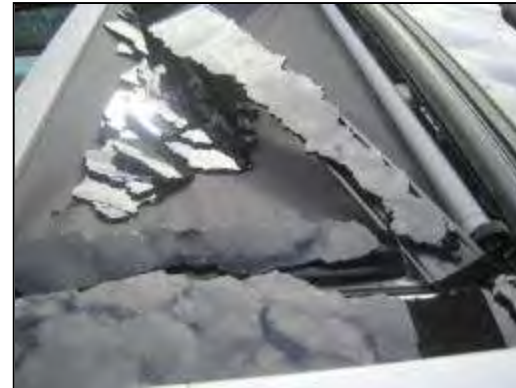
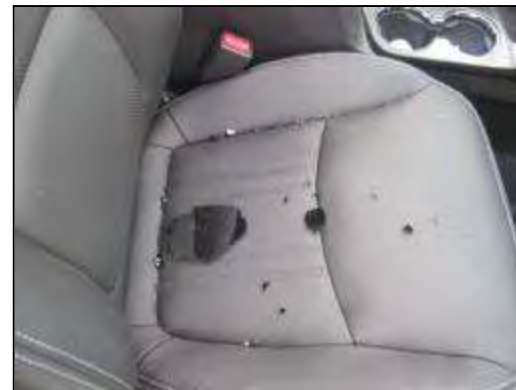
- Pictures directly above show the condition of the vehicle upon arrival to the dealership for investigation.
- Front bracket fell into the vehicle onto the customer after the fracture occurred. All glass on the front leading edge was displaced as customer was on the highway.
- Some of the glass was caught in the sunshade as it was partially open during the event. The remainder of the glass fell into the vehicle.
- No foreign objects were identified in the debris.

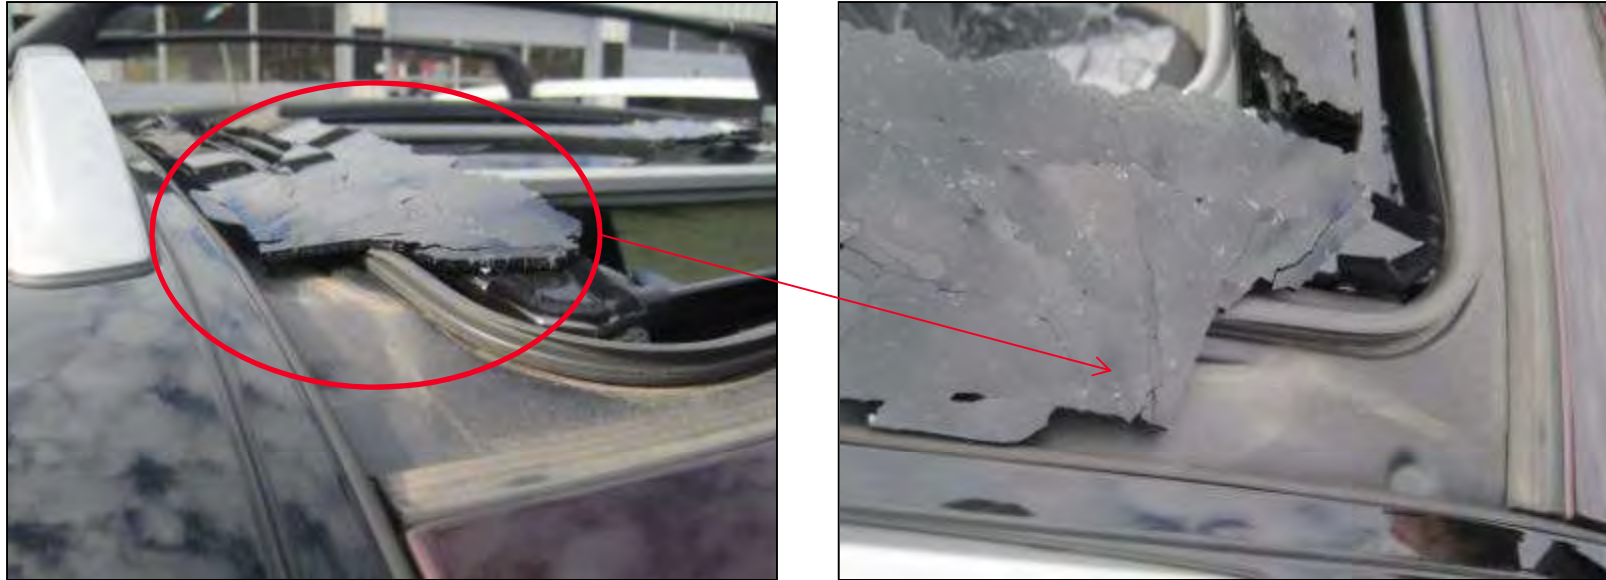
- Pictures directly above show area on the right side that has some web break pattern. But a lot of the glass from the front and edge are missing and difficult to say that this is 100% the origin of the break.
- Requested Webasto check their process to ensure glass is not being damaged in this area during assembly and requested Guardian, Glass supplier, to look at the glass in this area to determine if there are any issues that may compromise the integrity of the glass as this area is similar to previous occurrence.
